**REPORT OF THE AD HOC ADVISORY COMMITTEE
ADVISORS ON THE JULY 11, 2021, FLOODING AT THE
HYPERION WATER RECLAMATION PLANT AND
RECOMMENDATIONS FOR FUTURE IMPROVEMENTS**

February 11, 2022

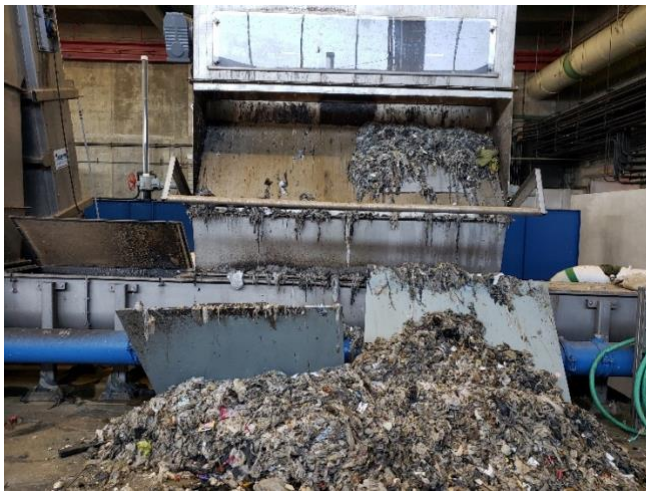
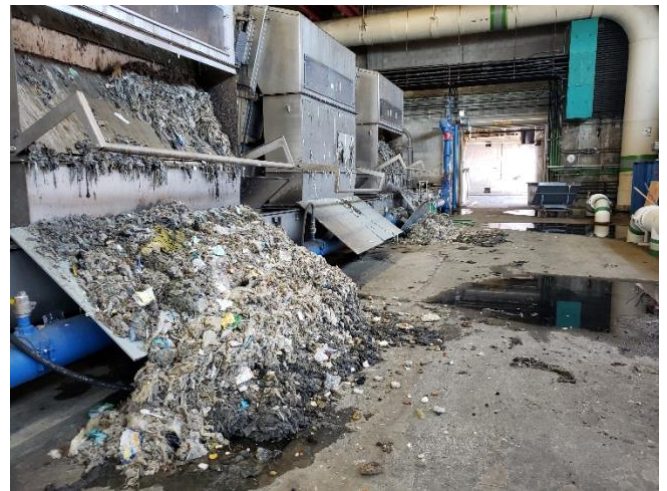
Figures 7 and 8: Back sides of the bar screens, opened to remove screenings (instead of using the sluice).

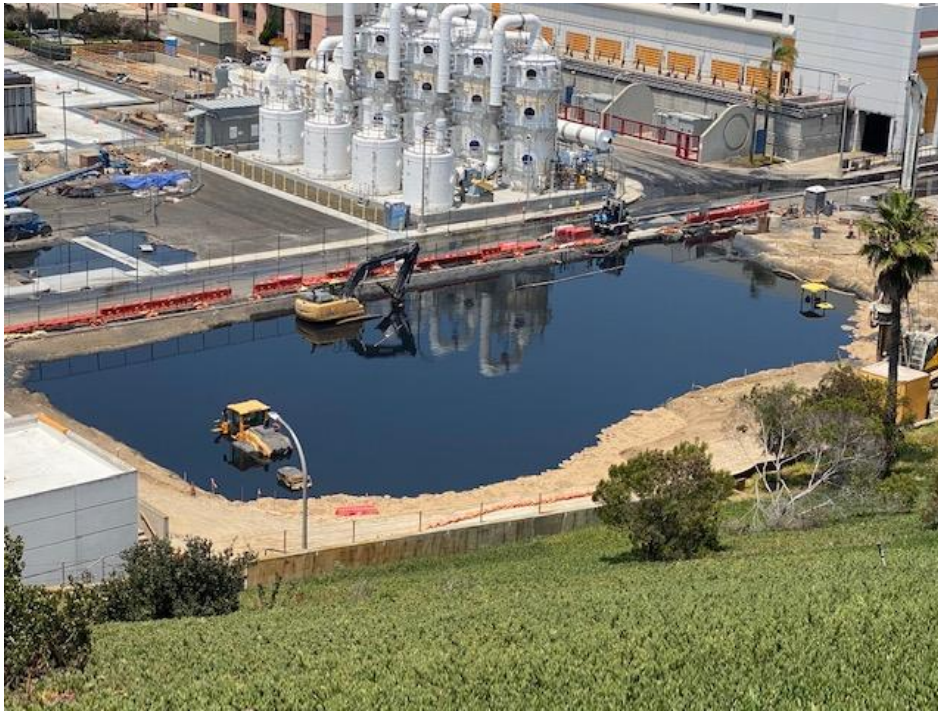
Figure 9: Construction area, outside of Headworks building, inundated by flood waters.

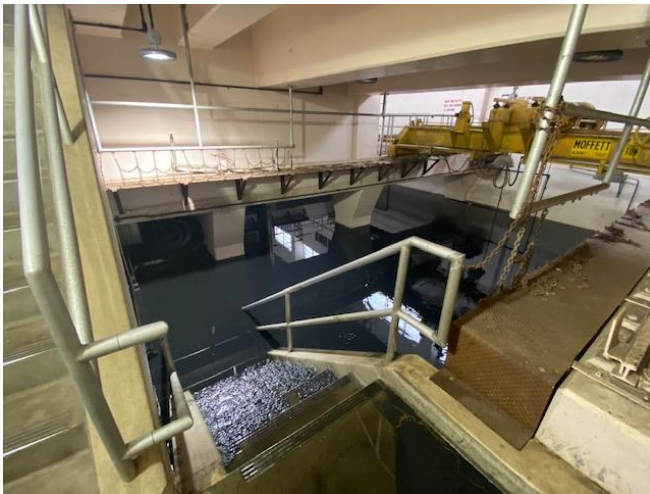
Figure 10: Flood waters in the EPP (Effluent Pumping Plant) basement area.

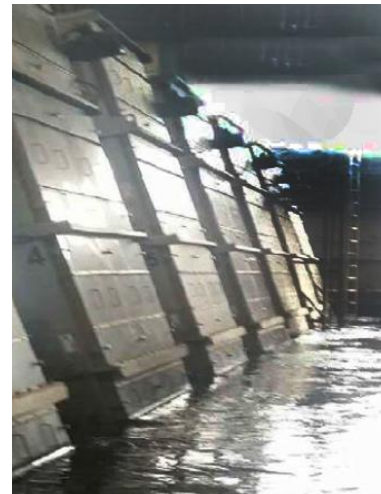
Figure 11: Flood waters in the Headworks building.

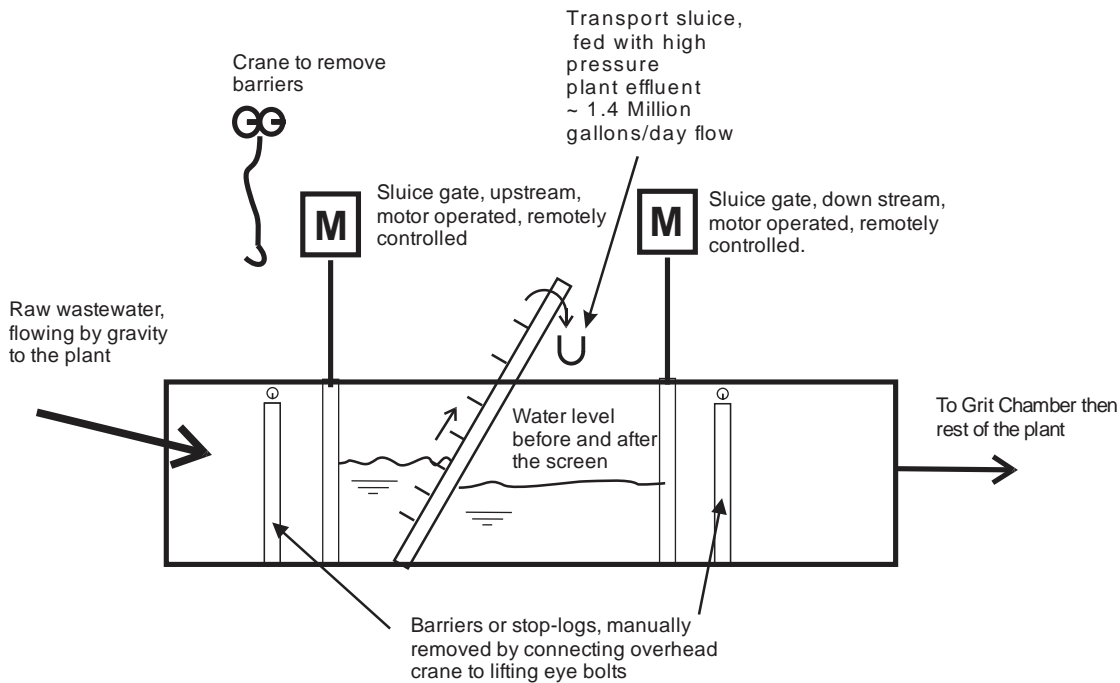
Figure 23: Elevation schematic of a bar screen with barriers and sluice gates. Note the water before and after the screen. The small difference is the head loss of the screen and the force required to push water through the screen. Normally this is 4.2 inches for the 3/8-inch screen to cause 133 million gallons/day flow rate.

Figure 23 shows a typical screen with two electrically operated gates and two manually operated barriers. Generally, gates mounted in tracks with screw positioners to raise and lower the gate and are called sluice gates. Gates that do not have positioners are called stop-logs or barriers. Both are designed to control flow at 0%, fully closed, or 100% fully opened. Their nature is such that they cannot accurately control in variable positions. Stop-logs or barriers are purposely simple but reliable devices which do not require routine maintenance and are used when the sluice gates, which are motor operated, require maintenance. Sluice gates that are not routinely maintained often seize due to corrosion. Treatment plants normally have both types of gates. Hyperion maintenance records show that the sluice gates were maintained routinely.

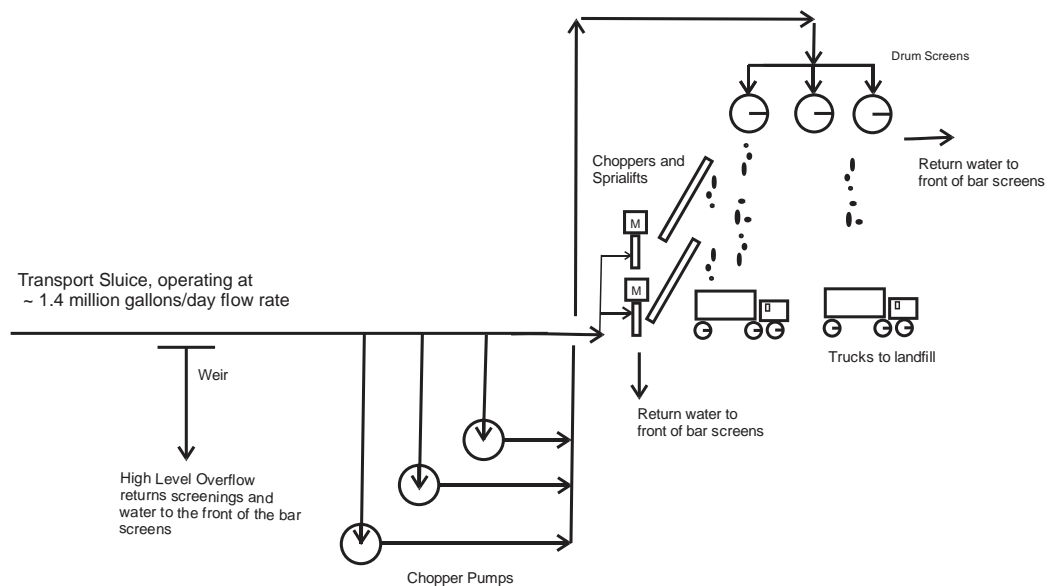
Figure 24: Schematic of screenings removal system. The sluice transports screenings to the pipes downward to the chopper pumps or to the choppers and spiral lifts. There is an overflow weir that allows water at high levels to overflow back to the front of the screen.

type of chopper. From there, the screenings are fed to a spiral lift, which is a type of screw conveyor and allows water to drain while transporting the screenings upward to be dumped into the same trucks. There are at least two hypothetical cases that could have caused the screens to blind. The Bureau of Sanitation's 30-day report [\(1\)](#) suggests that a large mass of debris entered the plant and blinded the screens. This report was created early in the investigation and was based on the best available information at the time. This potential cause is possible, but the subsequent Brown and Caldwell reports did not find evidence in the conveyance system of a previous or current accumulation of debris. The report did find an accumulation of grit near and around the sluice gates. Although grit normally does not blind screens, the accumulation may have contributed to the problem.

Prior to the event, the Bureau of Sanitation 30-day report also notes the failure of a chopper pump on July 11, and a spiral lift was out of service before July 11. Based on the investigation by CDM Smith, it appears possible that both systems to remove screenings could not keep up with the rate of removal of screenings and forced an overflow and recycling of screenings at the point shown in Figure 24. The Committee Advisors conclude that this is the most likely explanation for failure of the screens. Recycling of screenings would eventually overcome the bar screens and result in blinding and the increase of the wastewater level upstream of the screens. Under normal conditions, these screenings would have been transported to the trucks via the choppers. This recycling of screenings could have led to ultimate flooding of the Headworks.

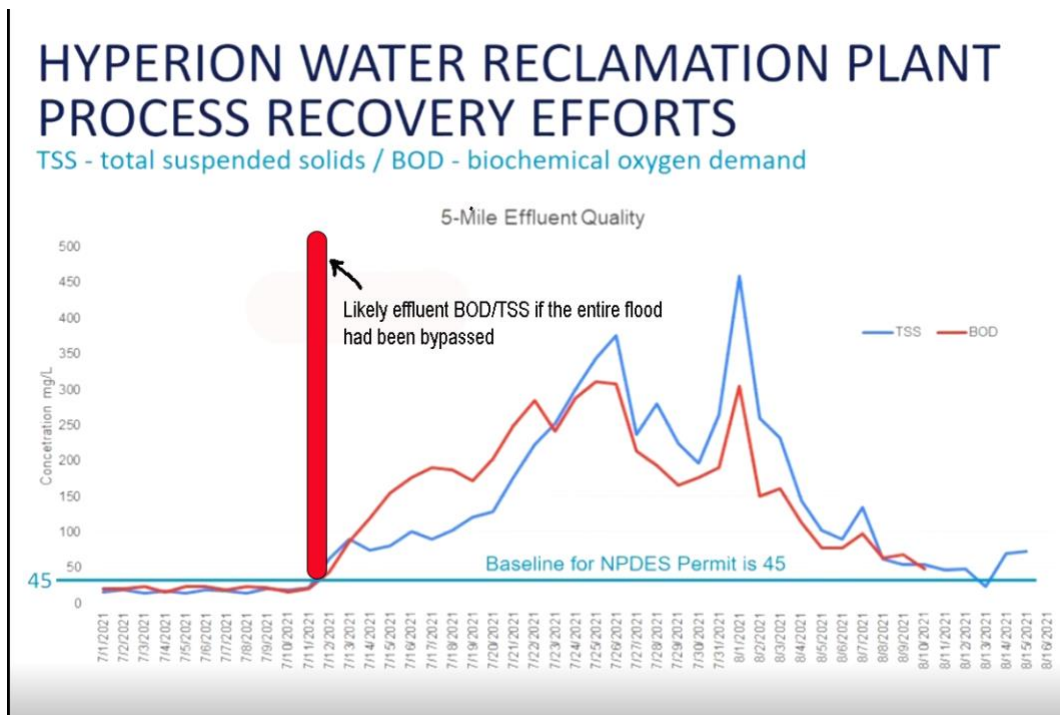
Figure 25: TSS and BOD discharges after the July 11 flood and a hypothetical discharge if all the flood water had somehow been diverted to outfalls, preventing damage to the plant.

The modeling predicts that a hypothetical diversion which could have avoided Hyperion damage would also have reduced BOD and TSS mass discharges by more than 99%. Because this hypothetical is based on a model, actual results can differ. Additional analysis is needed prior to invoking this approach to better ensure that the model results would reflect a real time flooding incident.

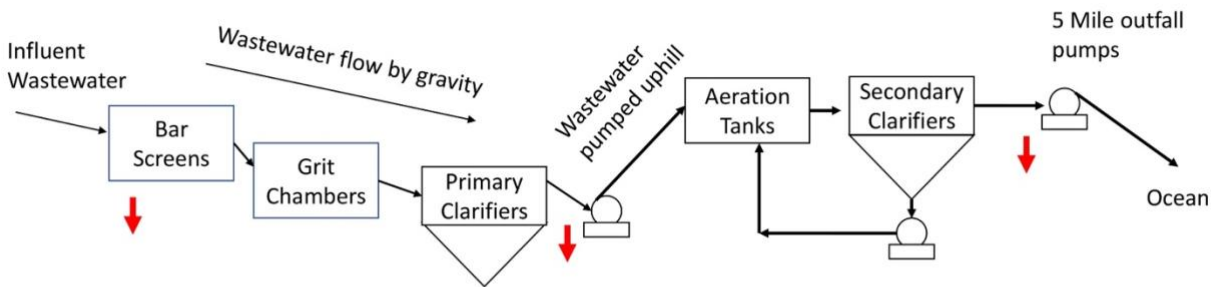
Figure 26 (below) shows a simplified hydraulic profile of the plant. The three most likely places where a flood could occur because of a massive power failure, earthquake, or tsunami damage are shown with

red arrows. A flood in any of these places could damage the plant as well as traveling to the beach if allowed to continue. The possibility of plant flooding could theoretically be avoided if the plant were reengineered such that the 5-or 1-mile outfall could be used as emergency diversion. The analysis should include gravity flow analysis, since during an extreme emergency power for pumps might not be available. The use of diversions to the outfalls would only be used under an extreme emergency, after any flood-control storage is full, and to avoid damage to the plant or discharge directly to the beaches.

Simplified hydraulic profile of the Hyperion Plant. Wastewater enters the plant by gravity flow and then flows through the bar screens, grit chambers and primary clarifiers, all by gravity. The primary effluent must be pumped upward to the secondary plant, aeration tanks and secondary clarifiers. The flow is then by gravity to the 5-mile outfall pumps where it finally leaves the plant.
