**REPORT OF THE AD HOC ADVISORY COMMITTEE
ADVISORS ON THE JULY 11, 2021, FLOODING AT THE
HYPERION WATER RECLAMATION PLANT AND
RECOMMENDATIONS FOR FUTURE IMPROVEMENTS**

February 11, 2022

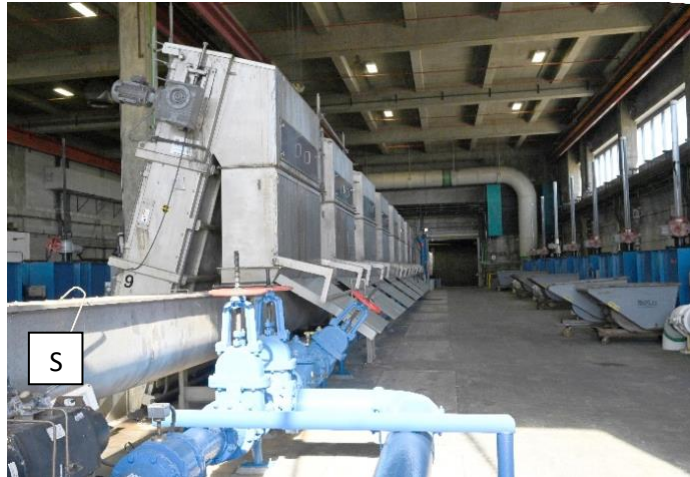
Figure 2: Array of eight Hyperion bar screens, sluice marked with S.

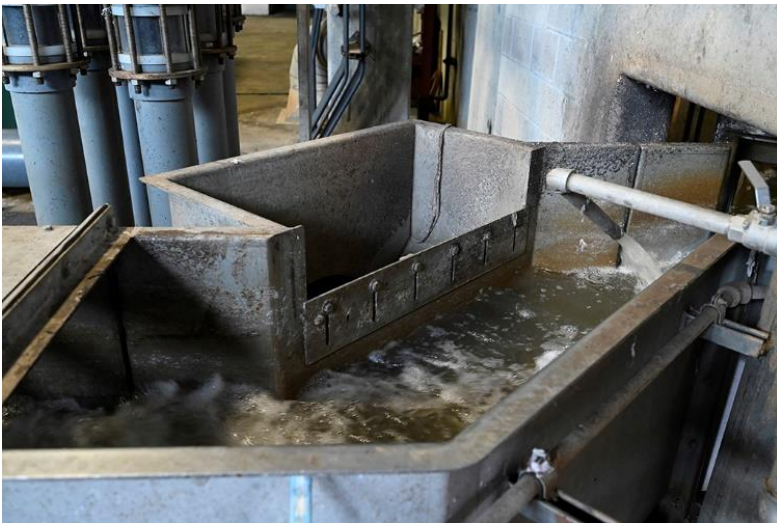
[Panel 3](#) (below) shows the sluice transporting screenings during normal operation, the connections between the sluice and the chopper pumps below, the emergency overflow weir which likely inadvertently recycled screenings, spiral lifts, and internals of the spiral lifts.

Figure 14: Sluice showing emergency overflow weir, sluice continues through the wall to chopper and spiral lifts.

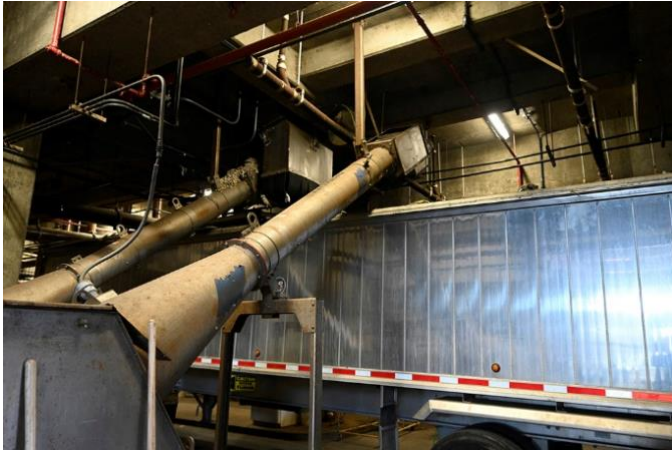
Figure 16: Spiral lifts lifting screening to a trailer for disposal

Prior to the event, the Bureau of Sanitation 30-day report also notes the failure of a chopper pump on July 11, and a spiral lift was out of service before July 11. Based on the investigation by CDM Smith, it appears possible that both systems to remove screenings could not keep up with the rate of removal of screenings and forced an overflow and recycling of screenings at the point shown in Figure 24. The Committee Advisors conclude that this is the most likely explanation for failure of the screens. Recycling of screenings would eventually overcome the bar screens and result in blinding and the increase of the wastewater level upstream of the screens. Under normal conditions, these screenings would have been transported to the trucks via the choppers. This recycling of screenings could have led to ultimate flooding of the Headworks.

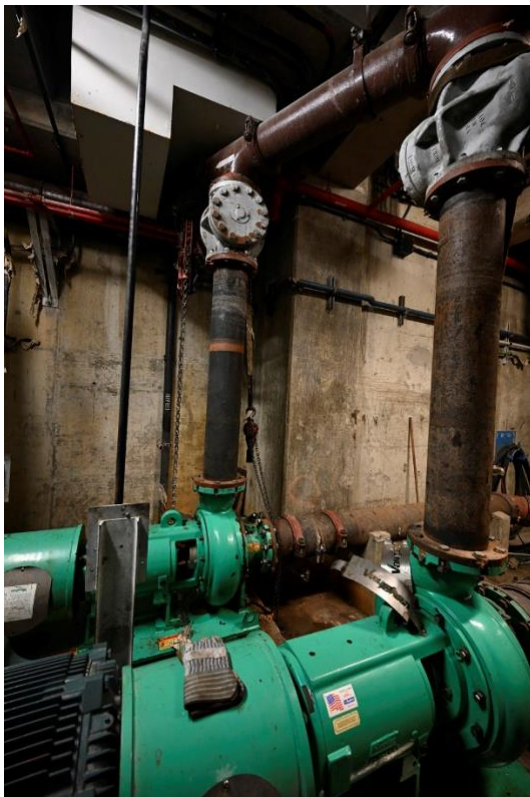
Figure 18: Chopper pumps showing discharge pipes leading upward to the dewatering drums.
